CASE STUDY:

Overlea Street, Nudgee

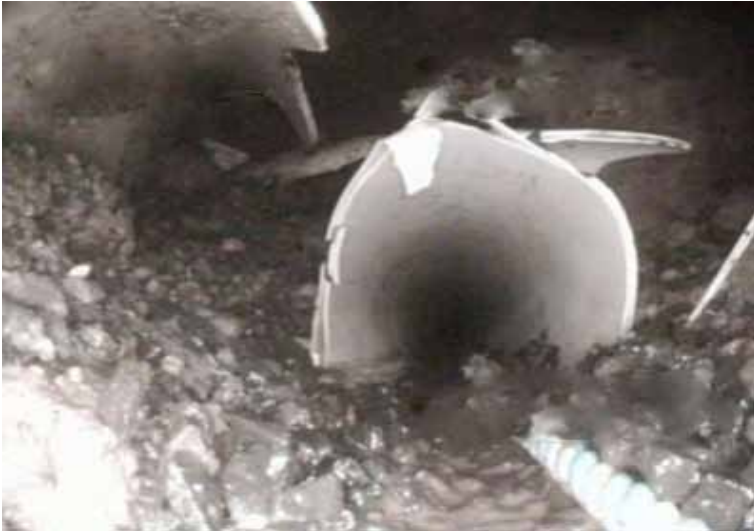
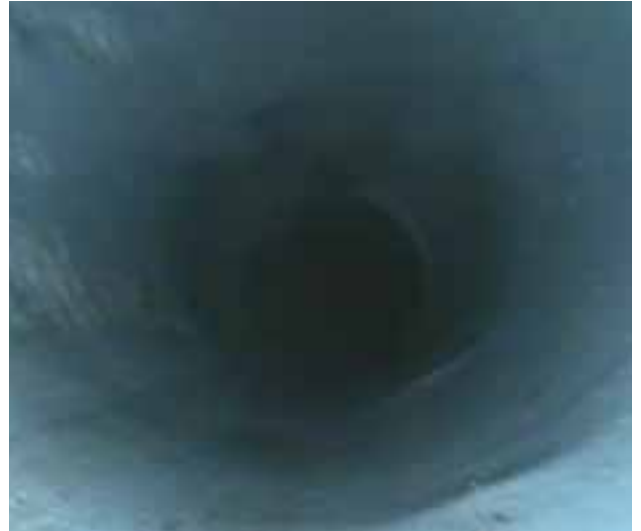
This sewer line wasn't 3 months old, and ran under a brand new house that had only recently become occupied by the new owners. The PVC section causing all the problems was completely broken away leaving over half a metre of void space with no pipe. This caused gravel to fill the line and undermine the house slab. Nuflow was able to reline without any excavation and disruption and have the sewer unblocked and working properly in less than a days work. Meanwhile the plumber who saved himself a lot of stress, was off on another job making money.

The sewer line of this brand new house was completely broken, allowing gravel to enter the pipe, undermining the integrity of the slab.

Reline 1m of 100mm PVC sewer line that was filled with gravel due to a serious break.

After carrying out the initial CCTV inspection, it was clear that we would need to spend some time removing some gravel from the line. There were 8 bends and 5 junctions to navigate in the 30m between our two access points. Eventually, after cleaning the line, we were able to locate the problem as broken section of pipe approximately 11m from an inspection opening. We custom made a liner for this job while on site and inserted it carefully using our drain cameras. Two hours later the liner was cured and the bladder removed to reveal a good job done.
