CASE STUDY:

Allawah Street, Bundall

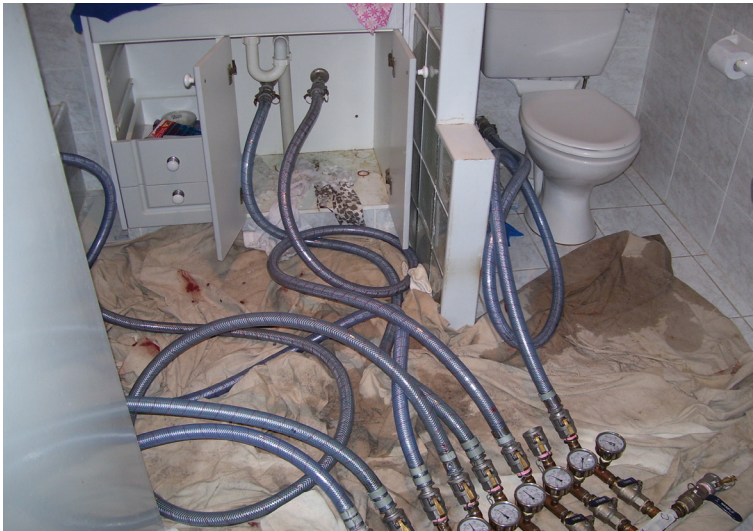
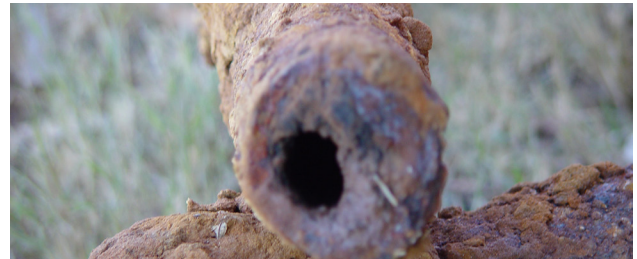
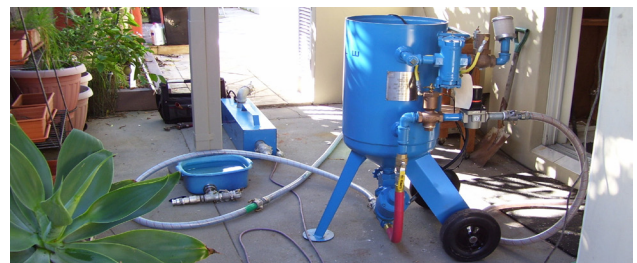
The initial call came because the water was coming out of the taps dirty and very slowly. Before Redline, the pipes capacity was reduced to as low as 35% due to the reduced bore size caused by corrosion. After Redline, the pipes were opened up to more than 95% of their original capacity.

Before Redline, the pipes capacity was reduced to as low as 35% due to corrosion. After Redline, the pipes were opened up to more than 95% of their original capacity.

At only 18 years old, the entire network of Galvanised Steel and Copper in this property, was in poor condition. Nuflow Redlined all the potable water pipes, from the meter to the internal pipe system within the house. This included 15mm galvanised external and 15mm copper hot and cold internal pipe work.

With a complete Redline over the inside of the pipe, there will be no more leeching of metals and rust, no more bad taste in the water, no more internal corrosion.
