## CASE STUDY:

# Jezzine Army Barracks

### Work Performed

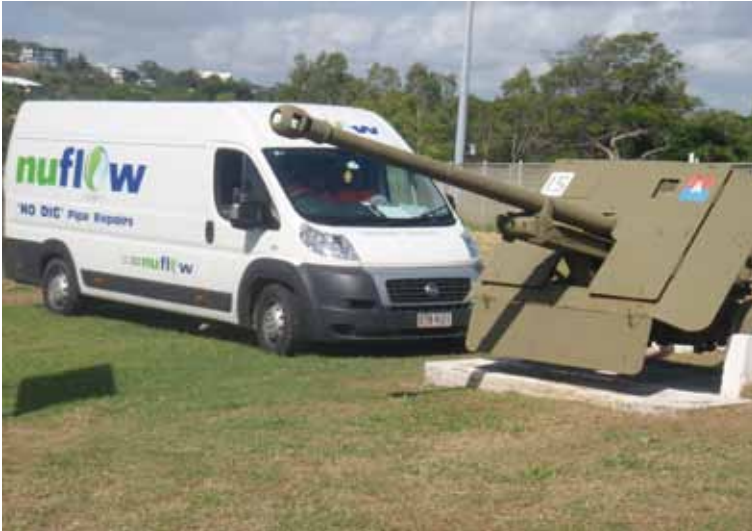
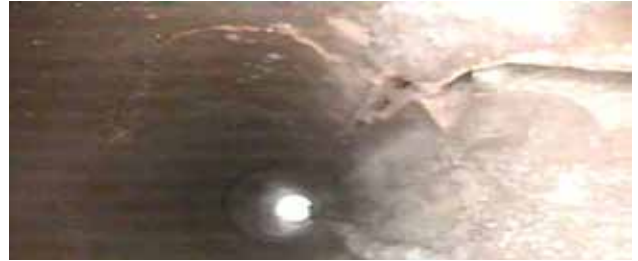
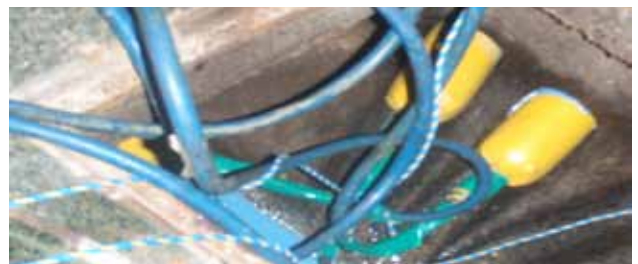
The camera inspection showed that all the earthenware pipes were either cracked or displaced, with a large amount of infiltration and exfiltration. The sewer was causing an environmental issue with sewerage leaching into the surrounding ground water and conversely salty groundwater infiltrating back into the pipe, adding to the cost of sewerage treatment. All the pipes required cleaning by high pressure jet, before final measurements and installation of liners could commence. The three man crew installed separate liners into junctions, traps and around multiple bends over a period of four days, completing the reline of the entire sewer.

Due to its historical significance, the alternative of excavating and replacing the damaged pipes was not an option. This would have caused lengthy delays to the redevelopment plans and site works, as it could have involved archaeological monitoring of any disturbed area of ground of this heritage listed site. Due to the location of the pipes and where they ran, many of the floor surfaces would have had to be removed. Tens of thousands of dollars were saved over a traditional dig and replace, under the assumption that the heritage foundation allowed for digging at all.
