CASE STUDY:

Zillmere Station, Brisbane

Work Performed

Cleared and Relined 41m of 150mm Earthenware and PVC sewer line which was badly broken and had seriously displaced joints for Queensland Rail.

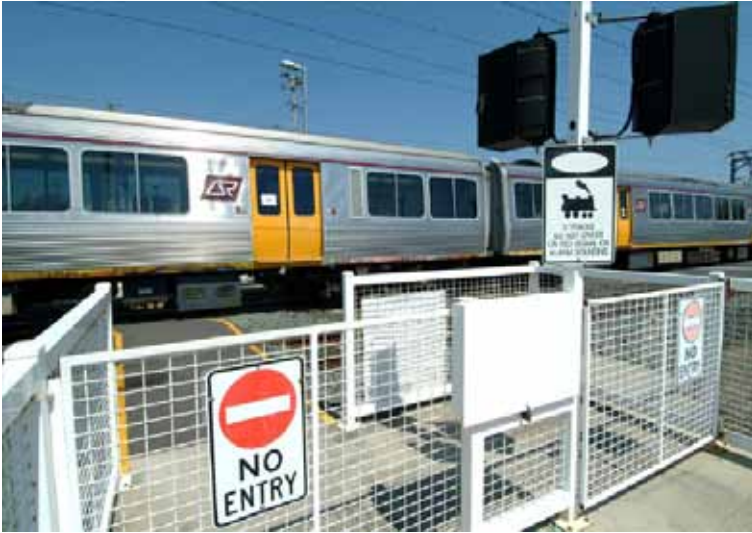
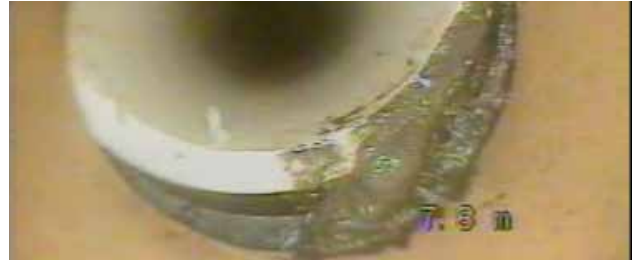
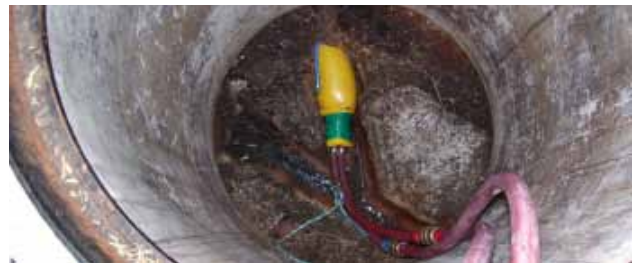
After carrying out the initial CCTV inspection, we were able to verify the problem as being several badly displaced joints and cracks with roots throughout. Almost every joint along the 41m of sewer line showed various degrees of these problems.

Using our latest resin technologies, and Hot Water Cure Systems, the line was structurally relined in less than 24 hours using a 3 man crew. The whole time during the works, the railway line and station was in operation.
