Jezzine Army Barracks

Earthenware and copper pipe relining

70 meters of 100mm earthenware pipe, along with 5 meters of 100mm copper pipe relining.

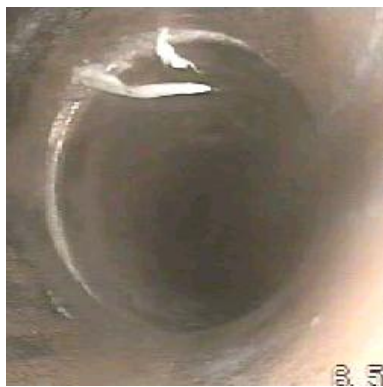
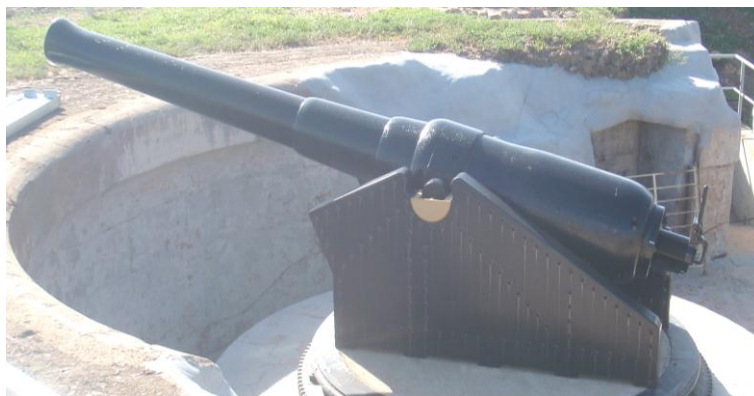
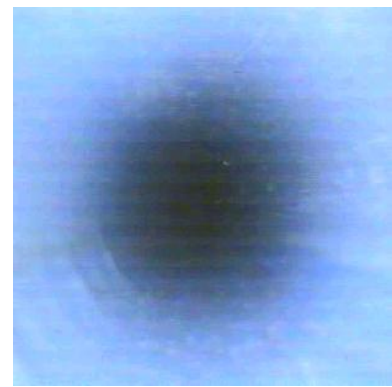
The CCTV investigation showed the problem as being all the earthenware pipes to be either cracked or displaced, with a large amount of infiltration and exfiltration. This was causing an environmental issue with sewerage leaching into the surrounding ground water. All the pipes required cleaning by high pressure jet, before installation of any liners could commence.
