# PRESSURE PIPE REPAIR & RELINING SOLUTIONS

# Our Redline technology

# Redline

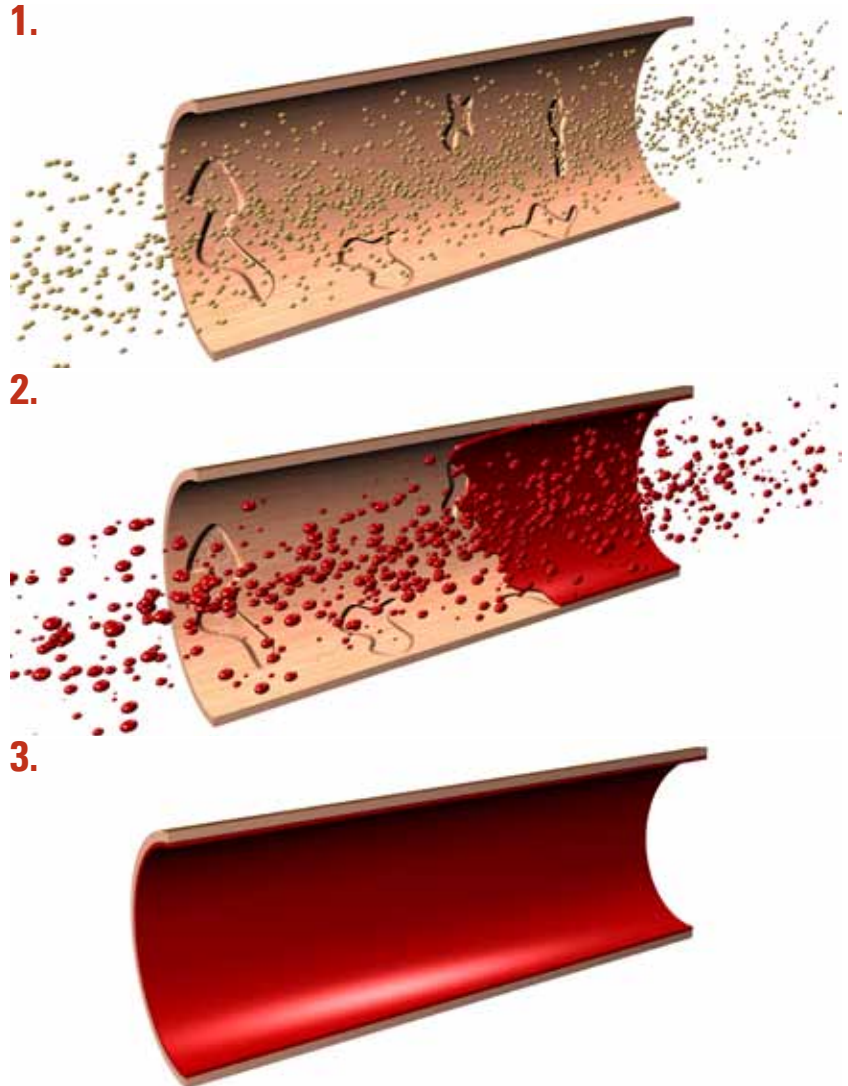
## The Redline process for drainage repairs:

1. The corroded pipes are blasted to prepare them for rehabilitation.
2. Shots of epoxy are moved through the entire pipe system using high pressure air.
3. The end result is a Redline barrier between the pipe system and the product that flows through them.

- Corroded pipes are sand blasted to prepare for rehabilitation.
- Shots of epoxy are moved through the entire piping system.
- End result is a Redline barrier between your pipes and your water.

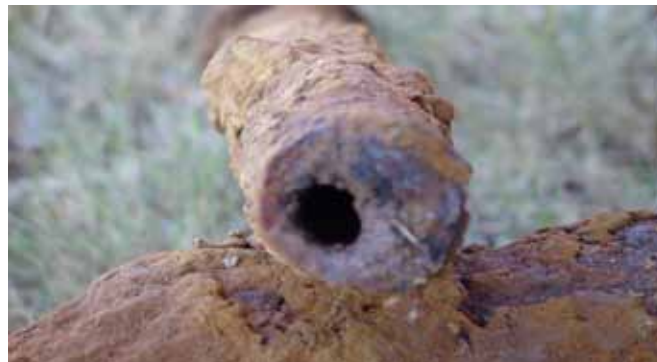
# Case study: Allawah Street

**Before Redline, the pipes capacity was reduced to as low as 35% due to the reduced bore size caused by corrosion. After Redline, the pipes were opened up to more than 95% of their original capacity.**

At only 18 years old, the entire network of Galvanised Steel and Copper in this property, was in poor condition. Nuflow Redlined all the potable water pipes, from the meter to the internal pipe system within the house. This included 15mm galvanised external and 15mm copper hot and cold internal pipework.

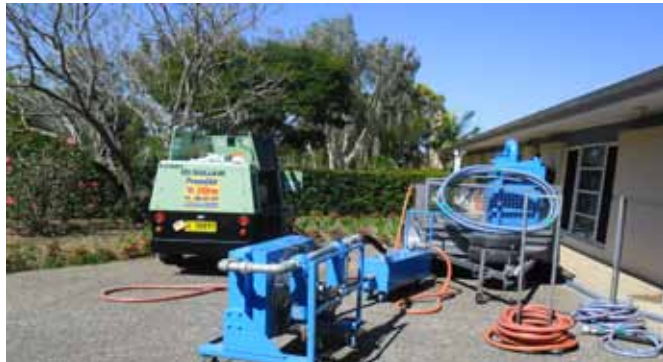
# Case study: Church St, Bellbowrie

**With a leaking service under the slab in the kitchen, without Redline the owners would have had to destroy the tiled area and excavate the kitchen floor to access the leaking pipe.**

Nuflow cleaned and Redlined all the internal 15mm copper hot water pipes as there was a leaking service contained under the slab in the kitchen.

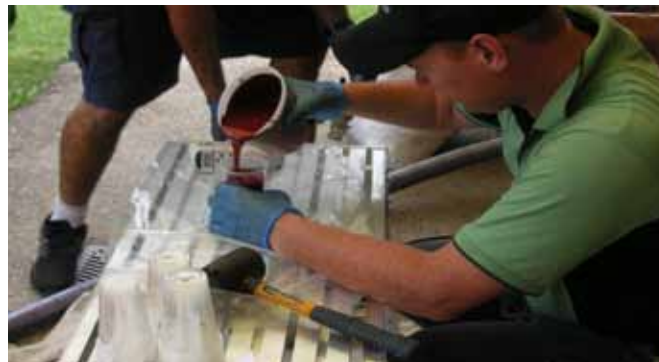
# Case study: Ewingar Court

**15mm copper potable water pipes were Redlined extending the life of the pipes exponentially and there will be no more water damage flooding caused by pin hole leaks in deteriorated pipes.**

Nuflow Redlined all the internal 15mm copper pipes in this detached granny flat. Both the hot and cold water systems were completed over 2 days with no excavation or digging into walls.

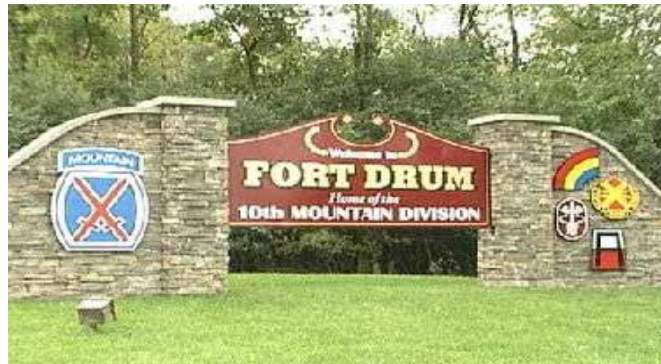
# Case study: Fort Drum, New York

**A job like this demonstrates how Nu Flow's patented epoxy coating is not limited to lining copper piping systems, but can also rehabilitate large fire suppression systems without destruction.**

2000 meters of iron pipes were Redlined. There were six bays, each with its own fire-suppression station. The aqueous film-forming foam (AFFF) distribution system consisted of 420 open sprinkler heads on six deluge systems. Pinhole leaks were occurring along with failing joints and causing failures and false alarms.
