## CASE STUDY:

# Hotel Broadway, Brisbane

3m reline patch in a 100mm Earthenware sewer pipe.

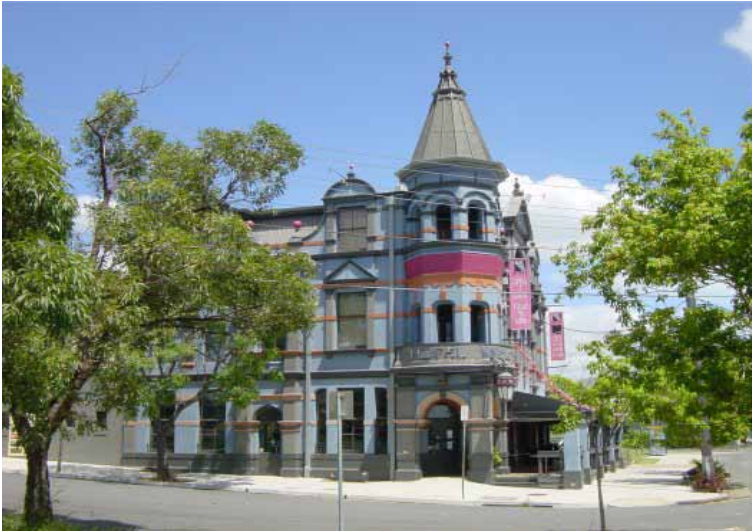
After carrying out the initial CCTV inspection, we were able to identify the problem as being a badly broken and displaced joint right beside a junction, and a length of root intruded pipe running from the cellar out into the hotel car park. The issue of sewerage overflow was made worse as the waste from the main bar entered the same sewer line. The line required high pressure jetting to unblock and clean and then relining in order to repair it.

Access to the sewer line was difficult as inspection openings were located in the cellar under the main bar. The line itself was attached to the floor joists of the bar, making it difficult to gain a point of access and a hole was eventually cut into the top of the line to allow for the works. Once this access hole was cut, a plug was inserted up stream so that we could work in the line without taking the toilets off line. The liner was inserted, and three hours later the bladder was removed leaving a line that was better than new. The Hotel was in operation during the reline process and no one was aware the repair was taking place.
