CASE STUDY:

Mingaletta St, Ashmore

15m reline of 300mm Reinforced Concrete Storm Water Pipe for Gold Coast City Council.

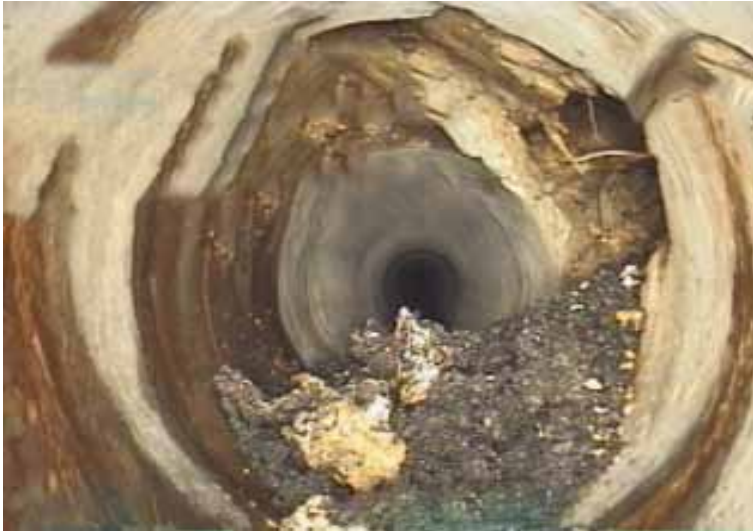
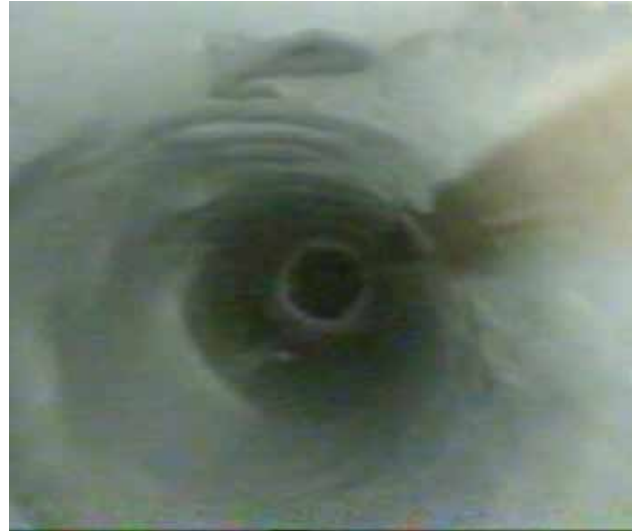
The road was constantly sink-holing into the pipe, this meant being patched after every time it rained.

After viewing the CCTV footage, there was a substantial hole 12m in from the manhole. Not only was the sinkhole in the middle of a road, but there were two large electrical conduits clearly visible, crossing directly over the top of the pipe. There was root intrusion and a large amount of bitumen in the pipe which had intruded from the sinkhole above. Nuflow high pressure jet cleaned the pipe and re-inspected the line before commencing the reline.

This liner was carried out using a Fast Cure resin over two 8m liners. The job was completed within 10 hours, with most of the residents not knowing we had even attended the job.
